**Flood Control Project Maintenance
Levee Inspections**

Fall 2018 Levee Maintenance Deficiency Summary Report

Sacramento River Basin

**Flood Control Project Maintenance
Levee Inspections****LMA District Cover Sheet****Fall 2018 Levee Inspection Results****Sutter Maintenance Yard Maintenance Area 0001**

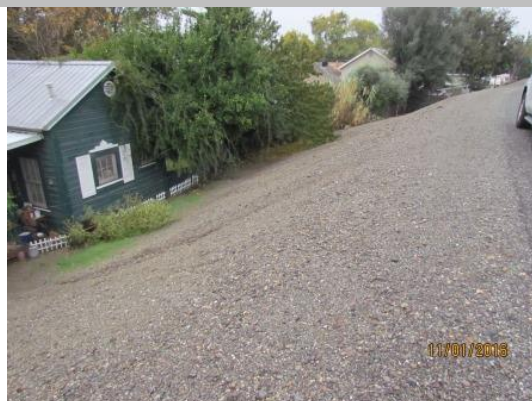
Photo 1 of 1 : FA_2018_MA0001_297_94_20180905_00027.jpg

LM Start	0.09	Rating **	M	Issue No.	94
LM End	0.09	Issue Type +	Ma	Location *	LS
Category	Earthen Levee			GPS Latitude/Longitude	
				Start	End
Item	Slope Stability			39.214217 °	39.214217 °
				-122.002378 °	-122.002378 °
DWR ID	DWR_MA0001_01_f_2016_94				
Comment Code					
S2 : Repair the levee slope damaged by foot traffic and prevent access where possible.					
Inspector Comment					
Repair the erosion along the damaged slope.

View of the slope instability along the landside slope.

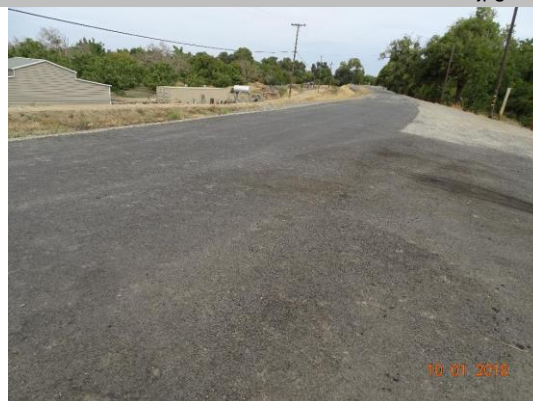
Photo 1 of 3 : UCIP_FA_2018_53078_78328.jpg

Comment Code						
Inspector Comment						
FS_ID:53078 DS_ID:25564 EP_NO: N/A Repair Type: Non-Urgent Crossing Status: Found UCIP Comments: 10/1/2018 Pipe installed according to emergency work authorization dated 07/31/2017 under existing permit No. 9481. Owner Roberts Ditch Company needs to submit as-builts. (O.Yakimov - DWR) FIELD_STRUCT_DESC: 36-inch smooth steel epoxy coated interior/exterior irrigation pipe with positive closure device on the water side of the levee. Crossing penetrates the levee at an angle. Other appurtenances located at this crossing include 2 slant pumps connected to a concrete distribution box, and shed structure located 100 feet northeast from levee crossing. Flow is carried from concrete distribution box to slide gate via concrete lined ditch. pipe is open to an irrigation ditch on LS. (Installed according to the board emergency work authorization dated 07/31/2017 under existing permit No. 9481. Owner Roberts Ditch Company). Replaces pipe with DSID 16431. FS Date: 10/1/2018 10:51:57 AM

View of levee crown at crossing.

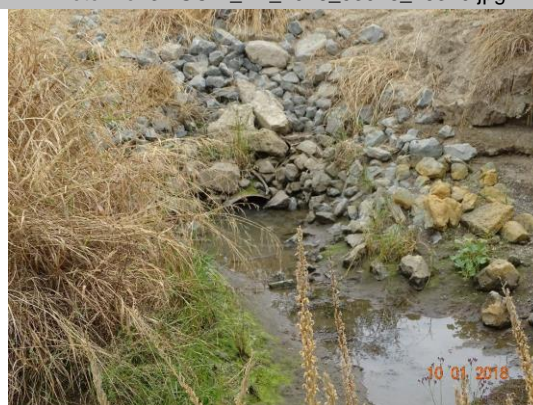
Photo 2 of 3 : UCIP_FA_2018_53078_78329.jpg

View of pipe end in irrigation ditch on LS.

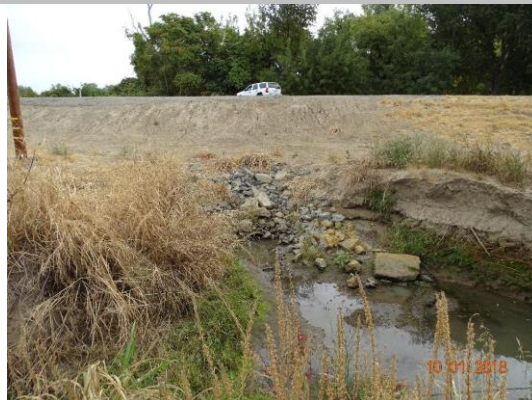
Photo 3 of 3 : UCIP_FA_2018_53078_78330.jpg

Comment Code						
Inspector Comment						
FS_ID:53078 DS_ID:25564 EP_NO: N/A Repair Type: Non-Urgent Crossing Status: Found UCIP Comments: 10/1/2018 Pipe installed according to emergency work authorization dated 07/31/2017 under existing permit No. 9481. Owner Roberts Ditch Company needs to submit as-builts. (O.Yakimov - DWR) FIELD_STRUCT_DESC: 36-inch smooth steel epoxy coated interior/exterior irrigation pipe with positive closure device on the water side of the levee. Crossing penetrates the levee at an angle. Other appurtenances located at this crossing include 2 slant pumps connected to a concrete distribution box, and shed structure located 100 feet northeast from levee crossing. Flow is carried from concrete distribution box to slide gate via concrete lined ditch. pipe is open to an irrigation ditch on LS. (Installed according to the board emergency work authorization dated 07/31/2017 under existing permit No. 9481. Owner Roberts Ditch Company). Replaces pipe with DSID 16431. FS Date: 10/1/2018 10:51:57 AM

View of LS levee slope and irrigation ditch at levee toe.

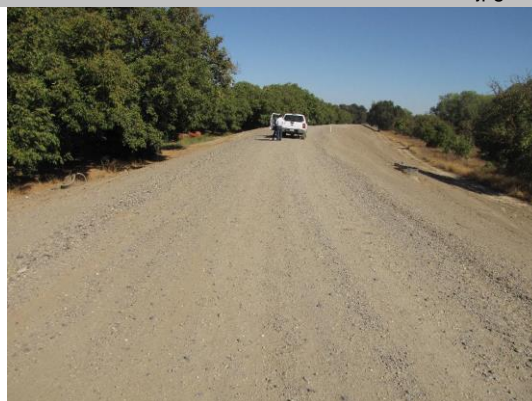
Photo 1 of 3 : UCIP_FA_2018_51852_70064.jpg

Comment Code						
Inspector Comment						
FS_ID:51852 DS_ID:16430 EP_NO: 9487 Repair Type: Non-Urgent Crossing Status: Found UCIP Comments: 5/3/2017 WS end still partially plugged. (DWR Sutter Yard- A Freitag)10/24/2016 Ws end is till partially plugged.(DWR Sutter Yard- A Freitag)4/25/2016 WS pipe end is still plugged with soil. Rest of the pipe appeared to be in good condition.4/20/2015 WS pipe end is plugged about 50% by soil.6/18/2014 Same as last inspection.12/17/2013 Same as last inspection.7/18/2013 WS pipe end has been reformed but is still clogged about 50% by sediment.10/18/2012 Remove dirt and debris in riser. Outlet deformed and blocked over 50%. Debris-round concrete section on landward side. This crossing was listed in the USACE Periodic Inspections as ID# USACE_CESPK_MA1C_2010_p_0116 for crossing outlet deformed and clogged with dirt. FIELD_STRUCT_DESC: 1 of 2: 36-inch corrugated metal drainage pipe through the levee, approximately 12-15 feet below the crown. Slide gates in corrugated metal pipe (CMP) riser located on the waterside (WS) slope. Pipe daylights on the landside (LS). (36-inch pipe [HLM 1.97] authorized under Automatic Board Order (ABO) issued as Permit No. 9487, 1974 - Jimeno Rancho) [Additional Reference(s): DWR Levee Log, 1992. USACE Sacramento O&M Manual 137, August 1955, (Station 103+18)]. FS Date: 5/19/2017 1:20:29 PM

Overview of levee crown and slopes looking upstream towards crossing.

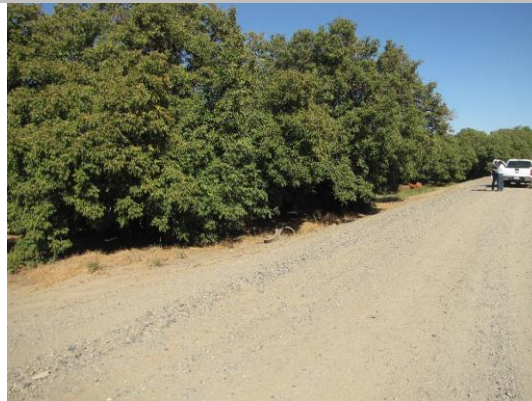
Photo 3 of 3 : UCIP_FA_2018_51852_70062.jpg

FS_ID:51852
DS_ID:16430
EP_NO: 9487
Repair Type: Non-Urgent
Crossing Status: Found
UCIP Comments: 5/3/2017 WS end still partially plugged. (DWR Sutter Yard- A Freitag)10/24/2016 WS end is still partially plugged. (DWR Sutter Yard- A Freitag)4/25/2016 WS pipe end is still plugged with soil. Rest of the pipe appeared to be in good condition.4/20/2015 WS pipe end is plugged about 50% by soil.6/18/2014 Same as last inspection.12/17/2013 Same as last inspection.7/18/2013 WS pipe end has been reformed but is still clogged about 50% by sediment.10/18/2012 Remove dirt and debris in riser. Outlet deformed and blocked over 50%. Debris-round concrete section on landward side. This crossing was listed in the USACE Periodic Inspections as ID# USACE_CESPK_MA1C_2010_p_0116 for crossing outlet deformed and clogged with dirt.
FIELD_STRUCT_DESC: 1 of 2: 36-inch corrugated metal drainage pipe through the levee, approximately 12-15 feet below the crown. Slide gates in corrugated metal pipe (CMP) riser located on the waterside (WS) slope. Pipe daylights on the landside (LS). (36-inch pipe [HLM 1.97] authorized under Automatic Board Order (ABO) issued as Permit No. 9487, 1974 - Jimeno Rancho) [Additional Reference(s): DWR Levee Log, 1992. USACE Sacramento O&M Manual 137, August 1955, (Station 103+18)].

View of LS looking upstream at crossing.

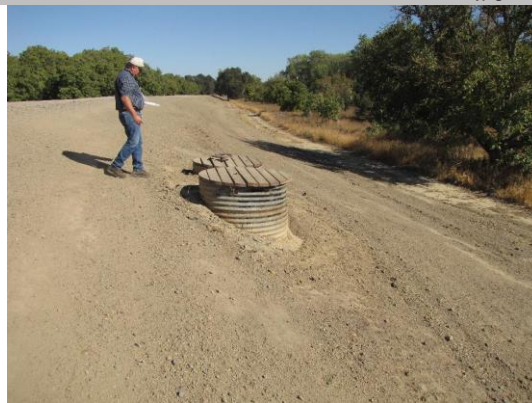
Photo 2 of 3 : UCIP_FA_2018_51853_70074.jpg

FS_ID:51853
DS_ID:17565
EP_NO: 9487
Repair Type: Non-Urgent
Crossing Status: Found
UCIP Comments: 5/3/2017 Ws end still partially plugged. (DWR Sutter Yard- A Freitag)10/24/2016 Ws pipe end still plugged.(DWR Sutter Yard- A Freitag)4/25/2016 WS pipe end still plugged with soil. rest of pipe appears in good condition.4/20/2015 WS pipe end plugged about 50% by soil.6/18/2014 Same as last inspection.12/17/2013 Same as last inspection.7/18/2013 WS pipe end has been reformed but is still partially blocked with dirt and debris.10/18/2012 WS-remove dirt and debris in riser. Outlet deformed and blocked over 50%. Burrow activity near outlet on waterward slope. Debris around concrete section on landward side. This crossing was listed in the USACE Periodic Inspections as ID# USACE_CESPK_MA1C_2010_p_0116 for crossing outlet deformed and clogged with dirt.
FIELD_STRUCT_DESC: 2 of 2: 36-inch corrugated metal drainage pipe through the levee, approximately 12-15 feet below the crown. Slide gates in corrugated metal pipe (CMP) riser on the waterside (WS) slope. Pipe daylights on the landside (LS). (36-inch pipe [HLM 1.97] authorized under Automatic Board Order (ABO) issued as Permit No. 9487, 1974 - Jimeno Rancho) [Additional Reference(s): DWR Levee Log, 1992. USACE Sacramento O&M Manual 137, August 1955, (Station 103+18)].

View of CMP risers located on WS slope.

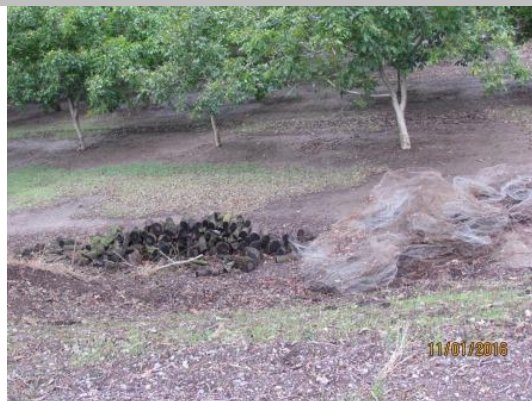
Photo 1 of 1 : FA_2018_MA0001_297_106_20180905_00030.jpg

View of the firewood along the landside toe.

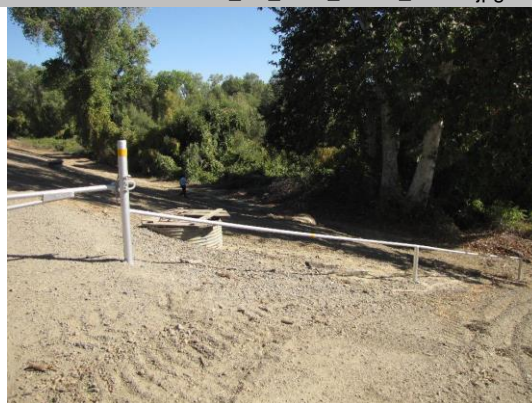
Photo 2 of 3 : UCIP_FA_2018_51854_70079.jpg

Comment Code						
Inspector Comment						
FS_ID:51854 DS_ID:16429 EP_NO: 9472 Repair Type: Non-Urgent Crossing Status: Found UCIP Comments: 5/3/2017 LS inlet partially plugged with soil. Some debris still present inside riser. (DWR Sutter Yard-AFreitag)10/24/2016 Debris still inside of riser.(DWR Sutter Yard-AFreitag)4/25/2016 Pipe still inside of riser and LS end plugged about 50% by soil.4/20/2015 Same as last inspection.6/18/2014 Same as last inspection.12/17/2013 Same as last inspection.7/18/2013 Same as last inspection.10/18/12 Remove debris from riser. Landward inlet is blocked by over 50%. This crossing was listed in the USACE Periodic Inspections as ID# USACE_CESPK_MA1C_2010_p_0128 for sediment build up at inlet (landward side) and debris inside riser. FIELD_STRUCT_DESC: 54-inch corrugated metal drainage pipe through the levee, approximately 12-15 feet below the crown. Slide gate in corrugated metal pipe (CMP) riser on the waterside (WS) slope. 48-inch CMP at landside (LS) slope. This crossing crosses the levee at an angle. (54-inch pipe [HLM 2.29] authorized under Automatic Board Order (ABO) issued as Permit No. 9472, 1974 - Ballard)) [Additional Reference(s): DWR Levee Log, 1992. USACE Sacramento O&M Manual 137, August 1955, (Station 120+00)]. FS Date: 5/19/2017 1:23:34 PM

View of WS looking at slope and channel.

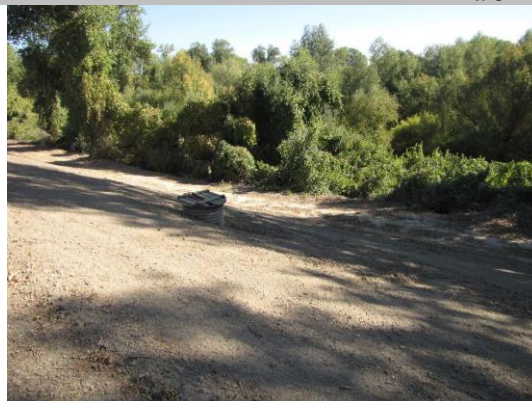
Photo 2 of 3 : UCIP_FA_2018_51855_70084.jpg

Comment Code						
Inspector Comment						
FS_ID:51855 DS_ID:16428 EP_NO: 9467 Repair Type: Non-Urgent Crossing Status: Found UCIP Comments: 5/3/2017 Abandoned- needs to be done so properly. (DWR Sutter Yard- A Freitag)10/24/2016 Abandoned.(DWR Sutter Yard- A Freitag)4/25/2016 Abandoned crossing. Unable to locate any WS and LS pipe ends.4/20/2015 Same as last inspection.6/18/2014 Same as last inspection.12/17/2013 Same as last inspection.7/18/2013 Same as last inspection.10/18/2012 Only riser visible. Debris and sediment blocking gate. Gate inside riser is buried and non-functional. If crossing is abandoned, owner needs to properly abandon. This crossing was listed in the USACE Periodic Inspections as ID# USACE_CESPK_MA1C_2010_p_0132 no culvert through the levee is visible here. FIELD_STRUCT_DESC: *ABANDONED* 24-inch corrugated metal drainage pipe through the levee, approximately 12-15 feet below the crown. Slide gate in CM pipe riser on the waterside (WS) slope. No signs of inlet visible on the landside (LS). (24-inch pipe [HLM 2.31] authorized under Automatic Board Order (ABO) issued as Permit No. 9467, 1974 - Lovell E. Spurgeon) [Additional Reference(s): DWR Levee Log, 1992. USACE Sacramento O&M Manual 137, August 1955, (Station 120+60)]. FS Date: 5/19/2017 1:48:04 PM

View of WS slope and toe.

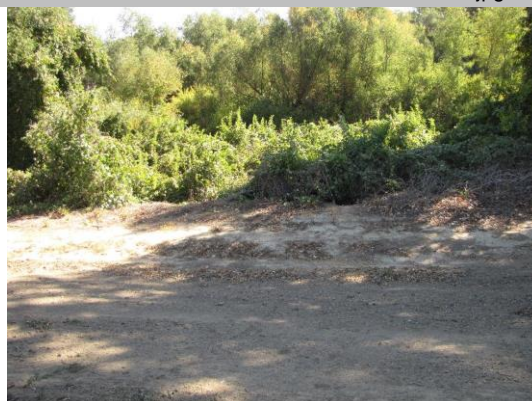
Photo 3 of 3 : UCIP_FA_2018_51855_70083.jpg

Comment Code						
Inspector Comment						
FS_ID:51855 DS_ID:16428 EP_NO: 9467 Repair Type: Non-Urgent Crossing Status: Found UCIP Comments: 5/3/2017 Abandoned- needs to be done so properly. (DWR Sutter Yard- A Freitag)10/24/2016 Abandoned.(DWR Sutter Yard- A Freitag)4/25/2016 Abandoned crossing. Unable to locate any WS and LS pipe ends.4/20/2015 Same as last inspection.6/18/2014 Same as last inspection.12/17/2013 Same as last inspection.7/18/2013 Same as last inspection.10/18/2012 Only riser visible. Debris and sediment blocking gate. Gate inside riser is buried and non-functional. If crossing is abandoned, owner needs to properly abandon. This crossing was listed in the USACE Periodic Inspections as ID# USACE_CESPK_MA1C_2010_p_0132 no culvert through the levee is visible here. FIELD_STRUCT_DESC: *ABANDONED* 24-inch corrugated metal drainage pipe through the levee, approximately 12-15 feet below the crown. Slide gate in CM pipe riser on the waterside (WS) slope. No signs of inlet visible on the landside (LS). (24-inch pipe [HLM 2.31] authorized under Automatic Board Order (ABO) issued as Permit No. 9467, 1974 - Lovell E. Spurgeon) [Additional Reference(s): DWR Levee Log, 1992. USACE Sacramento O&M Manual 137, August 1955, (Station 120+60)]. FS Date: 5/19/2017 1:48:04 PM

Unable to locate WS outlet.

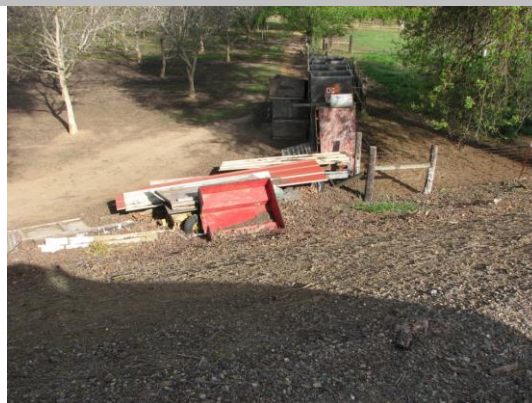
Photo 1 of 1 : FA_2018_MA0001_297_80_20180905_00018.jpg

LM Start	2.25	Rating **	M	Issue No.	80
LM End	2.25	Issue Type +	En	Location *	LS
Category	Earthen Levee			GPS Latitude/Longitude	
				Start	End
Item	Encroachments			39.236211 °	39.236211 °
				-122.012775 °	-122.012775 °
DWR ID	DWR_MA0001_01_s_2016_80				
Comment Code					
DE : Debris					
Inspector Comment					
Remove the metal roofing and other debris.

View of the equipment and debris obstructing access.

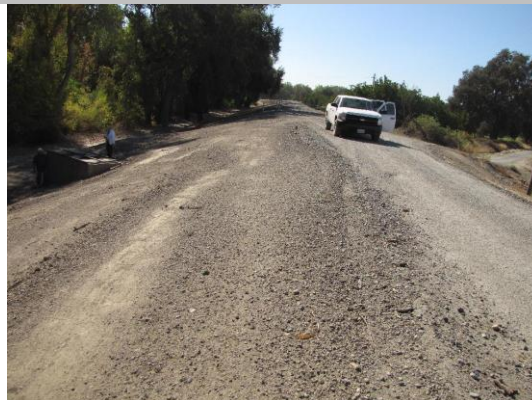
Photo 1 of 3 : UCIP_FA_2018_51856_70092.jpg

FS_ID:51856
DS_ID:16416
EP_NO: 9474
Repair Type: Non-Urgent
Crossing Status: Found
UCIP Comments: 5/3/2017 Appears abandoned- WS vault full of soil. Needs to be abandoned properly. (DWR Sutter Yard- AFreitag)10/24/2016 Appears to be abandoned. WS vault full of soil to help prevent water from flowing through during high water season.(DWR Sutter Yard- AFreitag)4/25/2016 Concrete box was filled with dirt to help prevent water from through during high water times.4/20/2015 Positive closure device is missing and water cannot be prevented from flowing through pipe during high water. 6/18/2014 Same as last inspection.12/17/2013 Same as last inspection.7/18/2013 Same as last inspection.10/18/12 During high water flow goes through levee. Missing positive closure device on waterward side. This structure appears abandoned-slide gates have been removed. Crossing needs to be properly abandoned. This crossing was listed in the USACE Periodic Inspection as ID# USACE_CESPK_MA1C_2010_p_0169 for concrete box partially filled with dirt.

Overview of levee crown looking downstream at crossing.

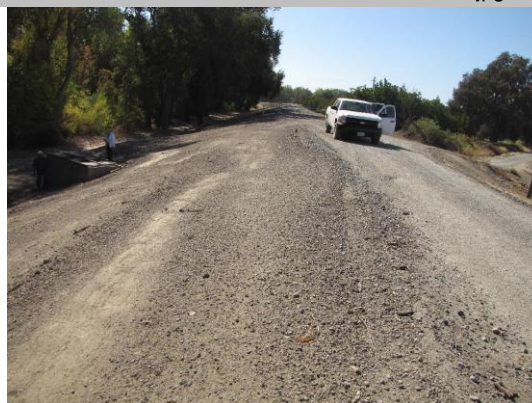
Photo 1 of 3 : UCIP_FA_2018_51857_70105.jpg

FS_ID:51857 DS_ID:17567 EP_NO: 9474 Repair Type: Non-Urgent Crossing Status: Found UCIP Comments: 5/3/2017 Appears abandoned- WS vault full of soil. Needs to be abandoned properly. (DWR Sutter Yard- AFreitag)10/24/2016 Appears to be abandoned. WS vault full of soil to help prevent water from flowing through during high water season.(DWR Sutter Yard- AFreitag)4/25/2016 Concrete box on WS was filled with soil to help prevent water form flowing through during times of high water.4/20/2015 Positive closure device is missing and water cannot be prevented from flowing through pipe during high water.6/18/2014 Same as last inspection.12/17/2013 Same as last inspection.7/18/2013 Same as last inspection.10/18/2015 During high water flow goes through levee. Missing positive closure device on waterward side. This structure appears abandoned-slide gates have been removed. Crossing needs to be properly abandoned. This crossing was listed in the USACE Periodic Inspection as ID# USACE_CESPK_MA1C_2010_p_0169 for concrete box partially filled with dirt. FIELD_STRUCT_DESC: 2 of 2: 60-inch reinforced concrete irrigation pipe through the levee, approximately 12-15 feet below the crown. Crossing goes through the levee at an angle. Slide gates in concrete well at the waterside (WS) toe. Slide gate missing. (Automatic Board Order (ABO) issued as Permit No. 9474, 1974 - George R. Zumwalt) O&M manual description is for two 5-foot by 5-foot concrete culverts with two hand operated slide gates. Culvert constructed with wing walls and gate well. [Additional Reference(s): DWR Levee Log, 1992. USACE Sacramento O&M Manual 137, August 1955, (Station 150+06)]. FS Date: 5/19/2017 1:49:51 PM

Overview of levee crown looking downstream at crossing.

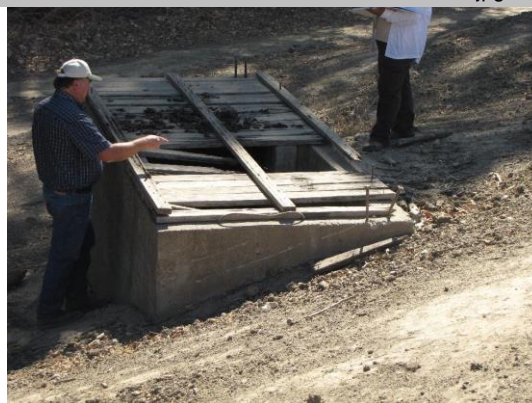
Photo 3 of 3 : UCIP_FA_2018_51857_70103.jpg

Close up view of concrete distribution box located on WS shoulder.

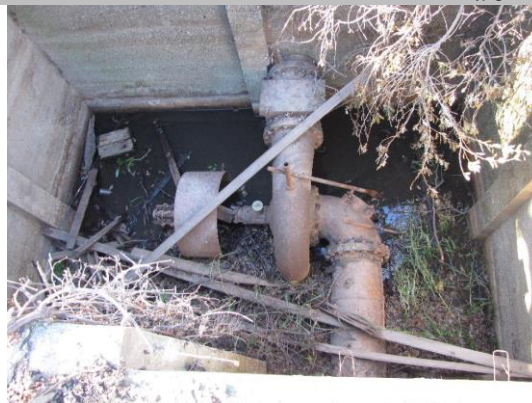
Photo 2 of 3 : UCIP_FA_2018_51861_70123.jpg

Abandoned pump system inside concrete structure located on LS.

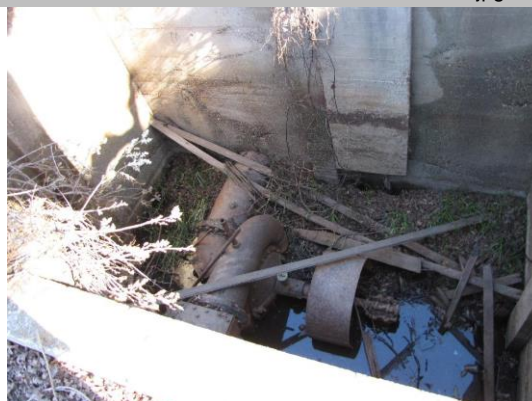
Photo 3 of 3 : UCIP_FA_2018_51861_70122.jpg

Debris inside concrete structure located on LS.

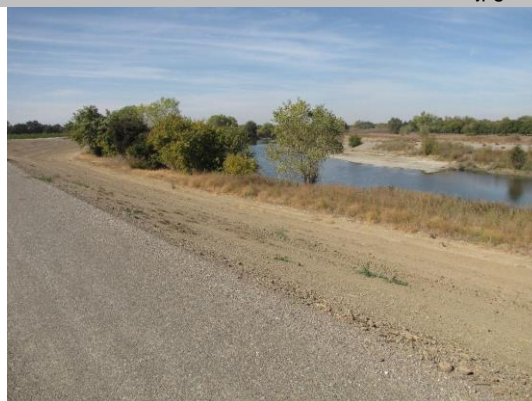
Photo 3 of 3 : UCIP_FA_2018_51868_70148.jpg

View of WS-no visible appurtenances associated with structure.

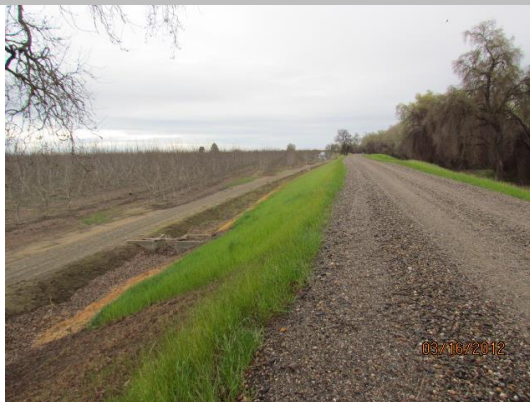
Photo 1 of 1 : FA_2018_MA0001_297_25_20180905_00011.jpg

View of the agricultural ditch along the L/S toe.

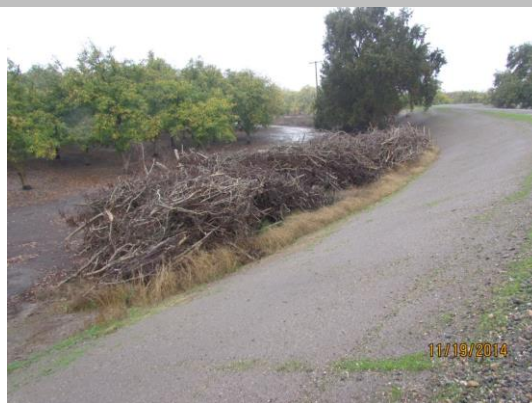
Photo 1 of 1 : FA_2018_MA0001_297_638_20180905_00044.jpg

View of the pruning along the landside toe.

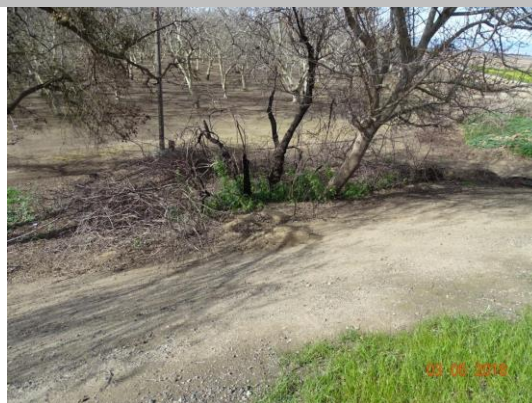
Photo 1 of 1 : FA_2018_MA0001_297_69_20180905_00016.jpg

View of the rodent holes along the landside slope.

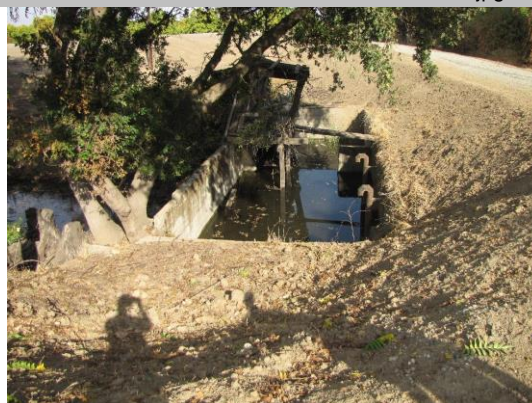
Photo 2 of 3 : UCIP_FA_2018_53052_70276.jpg

Abandoned structure (multiple headwalls and pump structure) located near the lower levee (ring levee).

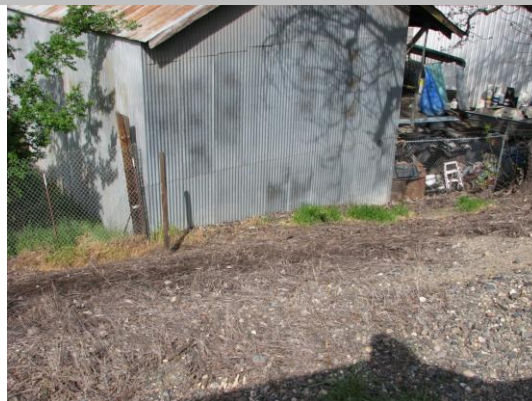
Photo 1 of 1 : FA_2018_MA0001_297_90_20180905_00024.jpg

View of a corrugated metal building obstructing visibility and access.
